Case study

Replacing main bearings in storm season

Main bearing replacement for FairWind's MCE team

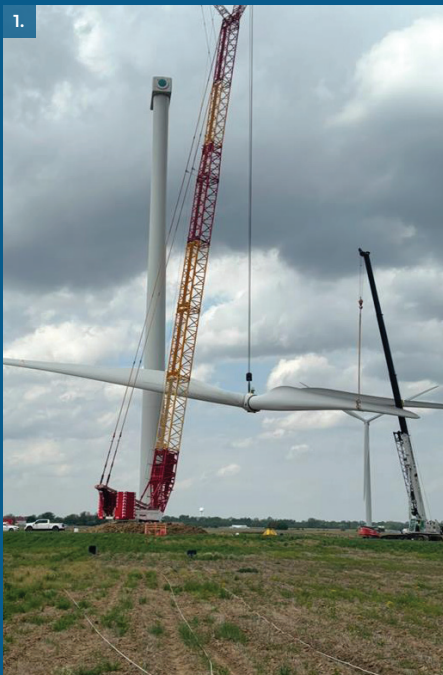
1. Lifting the rotor to the ground
2. Lowering the drivetrain
3. New drivetrain on trailer
4. Rotor on stand with banana beam.
